Ref: Pearson-10M #61

The toe rail area of the above referenced Pearson-10M needs additional reinforcing laminations.

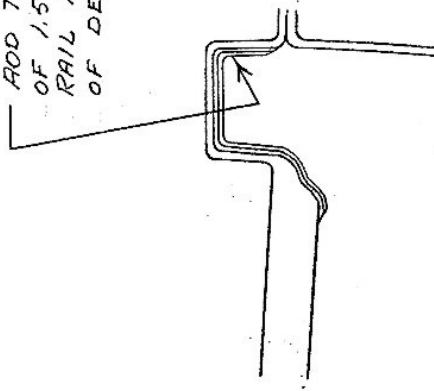
DIAGRAM 1  
5-5-75

The specific location is from genoa track to genoa track around the transom. This also includes the area under the genoa tracks. Any visible signs of weakness would be slight cracks parallel to, and on the inboard edge of the toe rail. In addition, the genoa track may show signs of lifting at the bolts.

PEARSON 10M  
TOE RAIL LAYOUT

1. Remove genoa track.
2. Lay up two strips of 1½ ounce or heavier mat per Diagram #1.
3. Make the layup wherever the underside of the toe rail is accessible, per Diagram #2.

ADD TWO (2) ADDITIONAL LAYERS  
OF 1.5 OZ MAT UNDER THE TOE  
RAIL AND LAPPING UNDER SIDE  
OF DECK AS SHOWN ON SHEET 2.

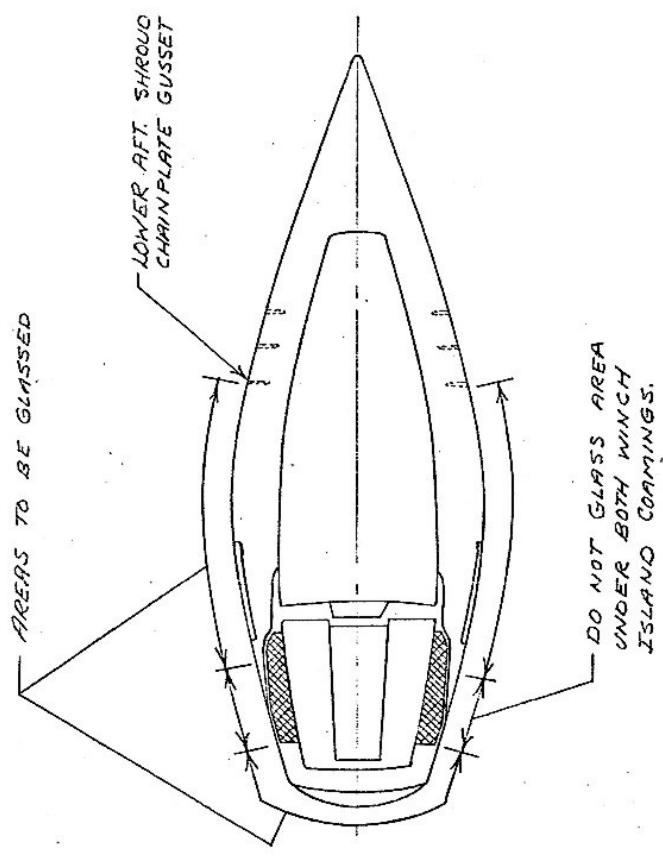
DIAGRAM 2  
5-5-75

PEARSON 10M  
AREAS TO BE FIBERGLASSED

AREAS TO BE GLASSED

DO NOT GLASS AREA  
UNDER BOTH WINCH  
ISLAND COAMINGS.

ADD TWO (2) ADDITIONAL  
LAYERS OF 1.5 OZ MAT  
INSIDE OF EXTERIOR PANEL  
COAMING SIDES ALL AROUND,  
INCLUDING TRANSOM AS  
SHOWN ON SHEET 2.  
THE AREA UNDER THE  
WINCH ISLANDS ARE TO BE  
EXCLUDED.
